Rehabilitation/Replacement of Route 44 over Mantua Creek Structure No. 0806-151

***Borough of Paulsboro &
Township of West Deptford
Gloucester County***

June 30, 2004

Problem Statement:

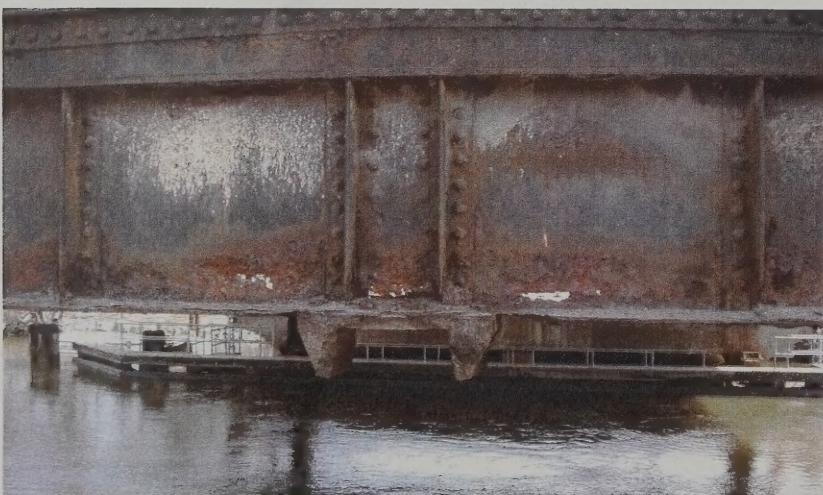
- Deteriorated through girder bottom flange angles on the lift span and west end floorbeam

Lift span floorbeam, south end, looking north. Note the section loss in the web and flange and the holes in the web.

Based upon a detailed review of the latest NBIS inspection report, cursory field visits, and structural analysis, it was determined that it is feasible to rehabilitate the existing superstructure, substructure and mechanical and electrical systems and obtain 25 to 35 additional years of service life. The bridge approach span decks may require replacement depending upon the results of the recommended deck condition survey. The lift span deck may also require replacement dependent upon the additional dead load introduced by the proposed repairs. **Rehabilitating the existing lift-span bridge satisfies the project need at a substantially lower cost than replacement. The estimated cost of rehabilitation is \$3.6 million.** The rehabilitation should also raise the bridge's sufficiency rating to 80 in order to remove it from the Department's select list.

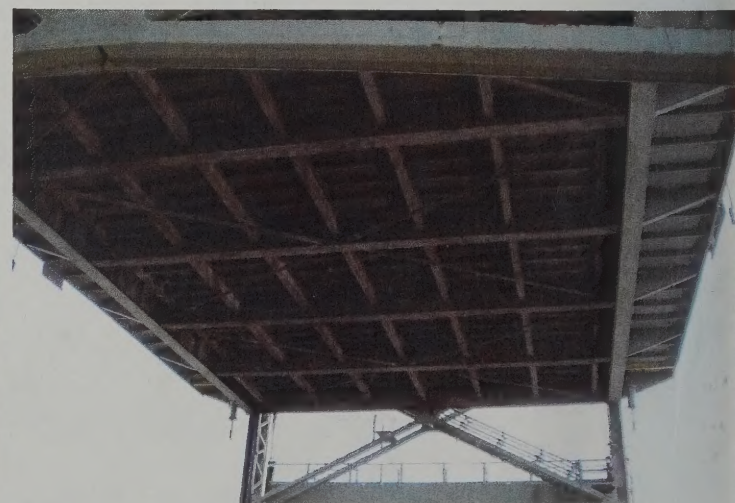
General view of the lift span.

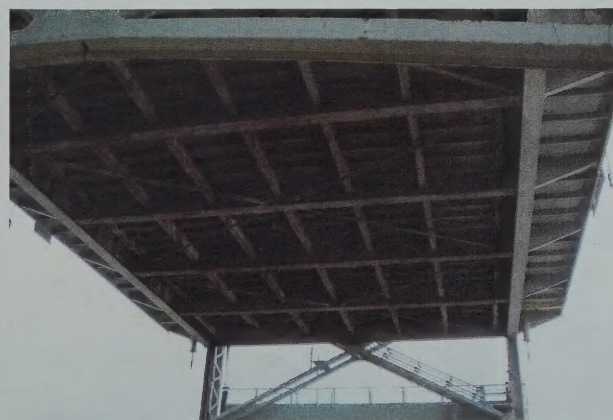
General view of the lift span.

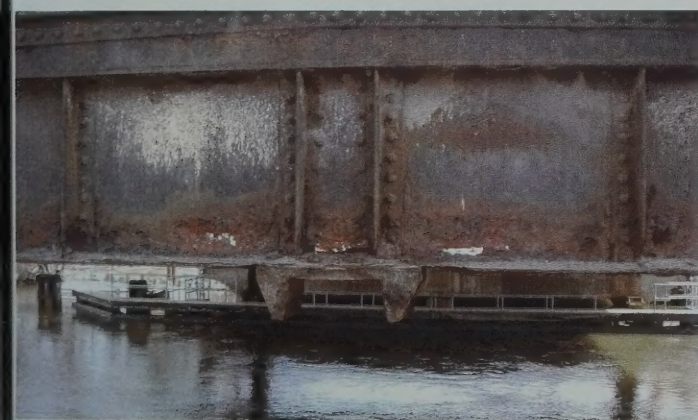
- Deteriorated through girder bottom flange angles on the lift span and west end floorbeam

Lift span floorbeam, south end, looking north. Note the section loss in the web and flange and the holes in the web.

Based upon a detailed review of the latest NBIS inspection report, cursory field visits, and structural analysis, it was determined that it is feasible to rehabilitate the existing superstructure, substructure and mechanical and electrical systems and obtain 25 to 35 additional years of service life. The bridge approach span decks may require replacement depending upon the results of the recommended deck condition survey. The lift span deck may also require replacement dependent upon the additional dead load introduced by the proposed repairs. **Rehabilitating the existing lift-span bridge satisfies the project need at a substantially lower cost than replacement. The estimated cost of rehabilitation is \$3.6 million.** The rehabilitation should also raise the bridge's sufficiency rating to 80 in order to remove it from the Department's select list.
